Technical Memorandum 78904

Technical Report 78-27(PL)

FRICTION AND WEAR OF CARBON-GRAPHITE MATERIALS FOR HIGH-ENERGY BRAKES

Robert C. Bill
Propulsion Laboratory
AVRADCOM Research and Technology Laboratories
Lewis Research Center
Cleveland, Ohio

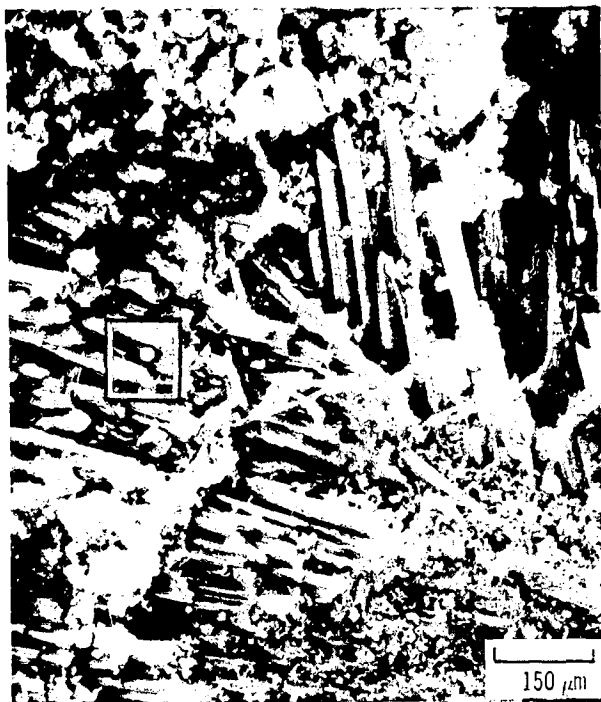
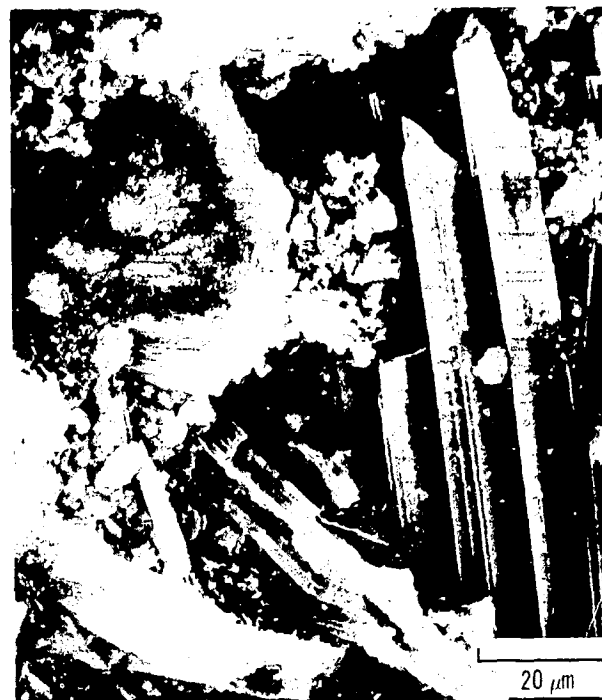
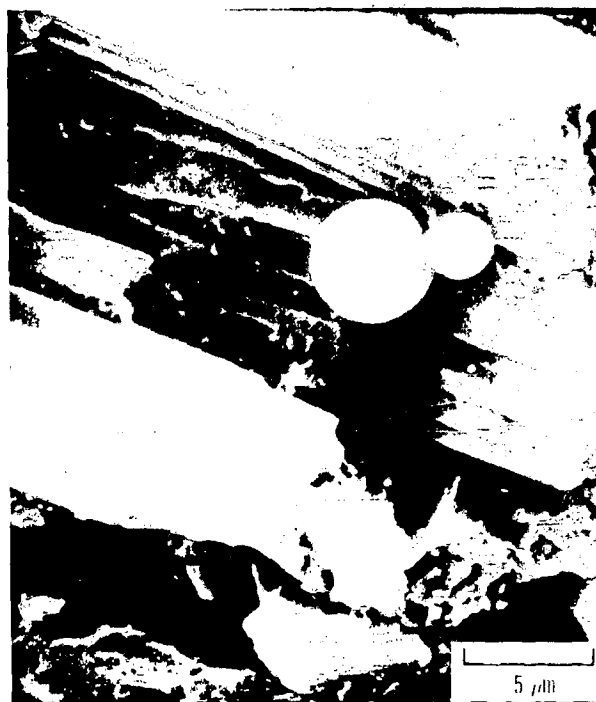
(a) Area of exposed fiber structure.

(b) Region in (a) showing fiber structure of reinforcing cloth.

(c) Enclosed region in (a).

Figure 10. - Surface of graphite-cloth-reinforced composite (GCRC) after sliding against a graphite-cloth-reinforced disk in simulated-stop - speed-variation test shown in figure 10.

The friction and wear of GCRC pads in sliding contact with the graphite-cloth-reinforced disk were markedly different from the preceding results. Even though wear rates to the pads (Table III(b)) were not significantly higher, instances of unstable transitions to severe wear and high, irregular friction (not reflected in the values shown in Table II) were observed. Furthermore, these transitions seemed to be irreversible. That is, once they occurred, severe wear and high friction were observed on subsequent sliding exposures, even after sufficient time interval to allow for specimen cooling, as shown in Fig. 9. The severe wear was accompanied by the generation of clouds of loose carbon debris being spewed from the contact area. The condition of the GCRC pad surface after such a sliding exposure was significantly different from that shown in Fig. 8. Exposed fibers are obvious in the SEM photographs of Fig. 10. A remarkable feature of the GCRC material shown in these photographs is the very irregular, sharp-edged fiber cross section. The lack of any coherent shear layer on the pad sliding surface is good evidence that fiber exposure ultimately leads to the disruption of this layer. The shape of the fibers and the high mechanical strength associated with them would enable them to act as potentially abrasive constituents on the pad surface.
